Loss of Control on Approach  
Colgan Air, Inc.  
Operating as Continental Connection Flight 3407  
Bombardier DHC-8-400, N200WQ  
Clarence Center, New York  
February 12, 2009

NTSB/AAR-10/01  
PB2010-910401

# Aircraft Accident Report

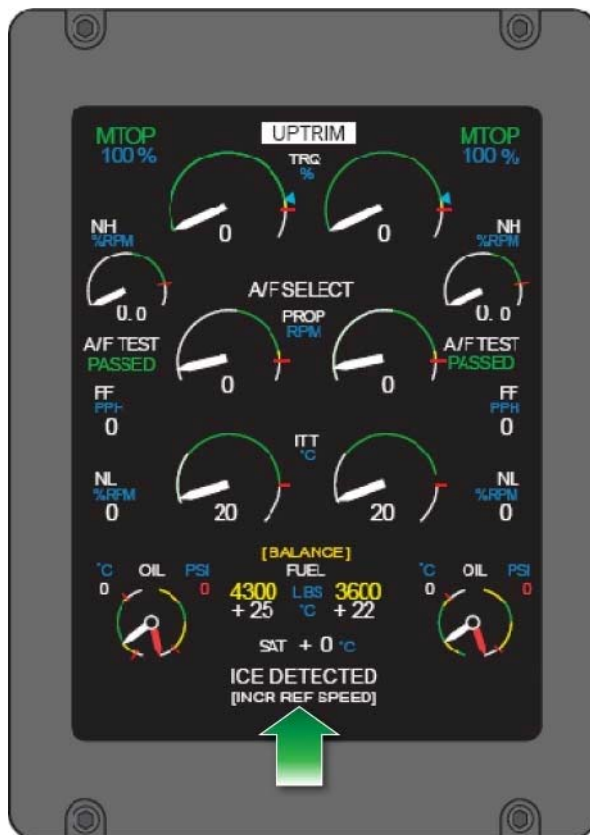
The Q400 engine display shows an “ICE DETECTED” message, as shown in figure 3, when one or both ice detector probes detect more than 0.5 millimeter (0.02 inch) of ice. The message appears in reverse video (black letters on a white background) for 5 seconds if the ref speeds switch has already been set to the increase position. After the 5-second period, the message appears in normal video (white letters on a black background, as shown in figure 3) when ice is detected and the ref speeds switch remains set to the increase position. If the ref speeds switch is set to the off position when ice is detected, the message flashes with yellow letters on a black background until the switch is turned to the increase position. In addition, when the switch has been selected to the increase position, an “INCR REF SPEED” message (also shown in figure 3) appears in normal video, regardless of whether ice has been detected.

**Figure 3.** Q400 Engine Display Showing Ice Detected and Increased Reference Speeds Message
